Federal Highway Administration
Every Day Counts
Innovation Initiative

Safety Edge$_{SM}$
PCC Demonstration Project
County Highway E34
Fairview, Iowa

Field Report
June 10, 2011

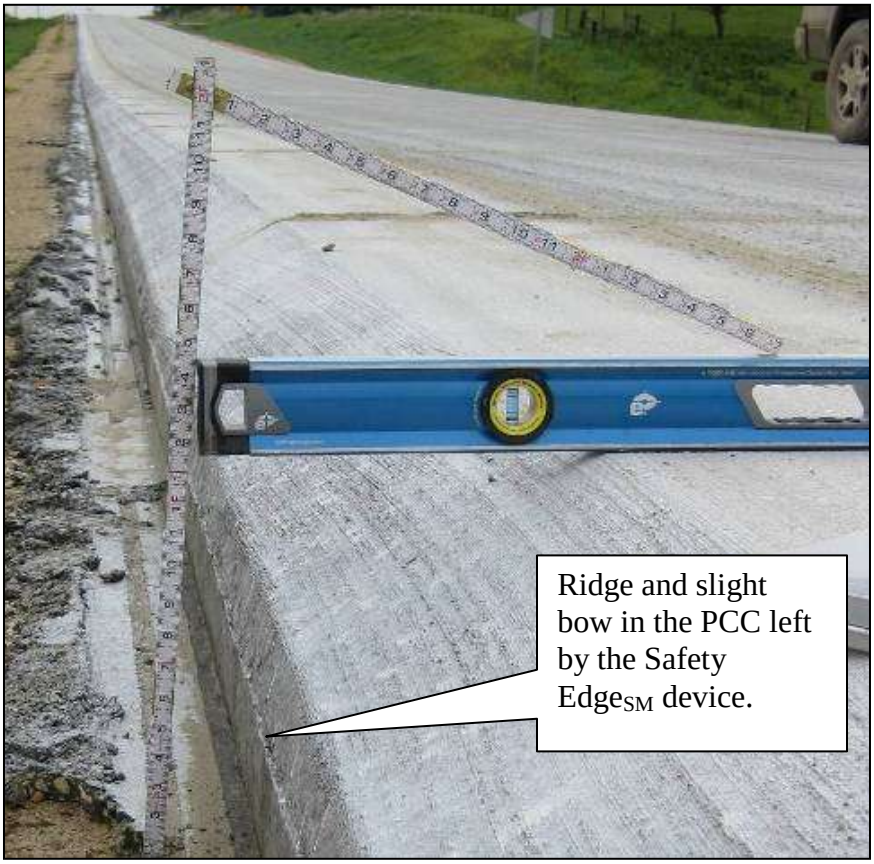
Figure 5. Slope face showing ridge and bow.

Some deviation in the flatness of the slope face was observed. The flatness was measured by placing a straightedge on the face as shown in Figure 4. The face was found to be concave in some cases and convex in other cases. This condition may be caused by either flexing of the device or issues during finishing. The deviation from flat is generally considered minor and is not expected to have a significant impact on the performance of the Safety Edge$_{SM}$.

Similarly, the vertical edge face of the pavement was found to have defects from forming. The Safety Edge$_{SM}$ device did not always seal tightly against the end gate, leaving a ridge in the face. Figure 5, shows an example of this. The vertical face is bowed and the marks created by the end of the device and the end gate can be clearly observed.

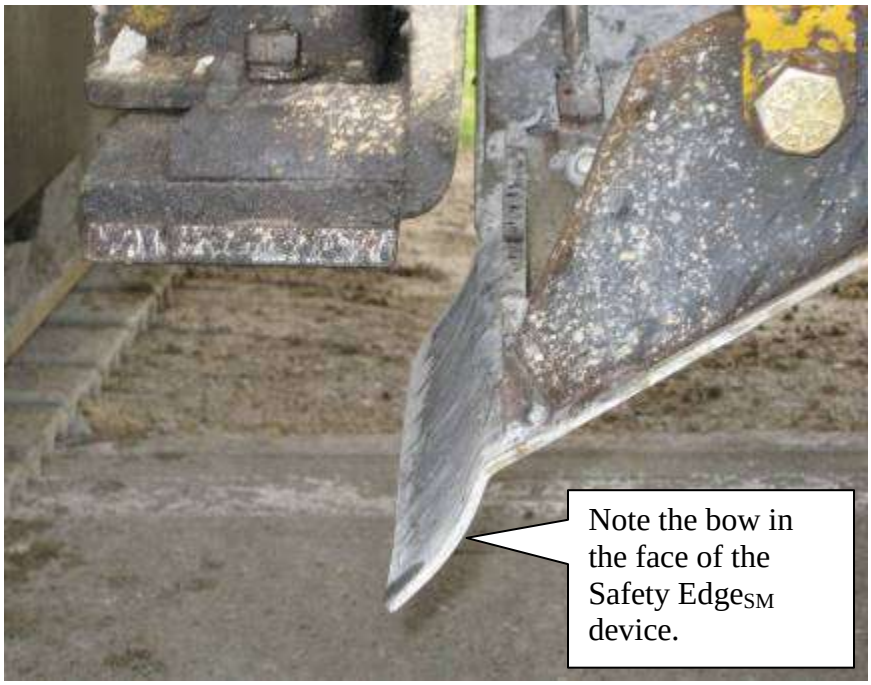
Figure 15. Viewed from the rear of paver showing the bend in the Safety Edge$_{SM}$ device.

The Safety Edge$_{SM}$ device can be seen in Figure 14. The device in Figure 15 is shown welded to the back of the pan and sits closely to the end gate. It is evident that the device has been bent. The contractor indicated the device was bent during transport operations. This bend in the device can be seen in the pavement as a bow in the exposed vertical face of the pavement edge.

- The slope was generally found to be appropriate. The average slope was 31.5° with a maximum value of 34.0° and a minimum value of 28.5°.
- A slight hump or bow in the slope face was produced by the Safety Edge$_{SM}$ device. Modifications to the device and a more robust design should be considered to prevent this problem on future projects. Unlike the Safety Edge$_{SM}$ attachments for asphalt pavers, the PCC device on the concrete paver requires more time and effort to install or modify once paving begins.
