Federal Highway Administration
Every Day Counts
Innovation Initiative

Safety Edge$_{SM}$ Demonstration Project Turner, Maine

Field Report
June 15, 2011

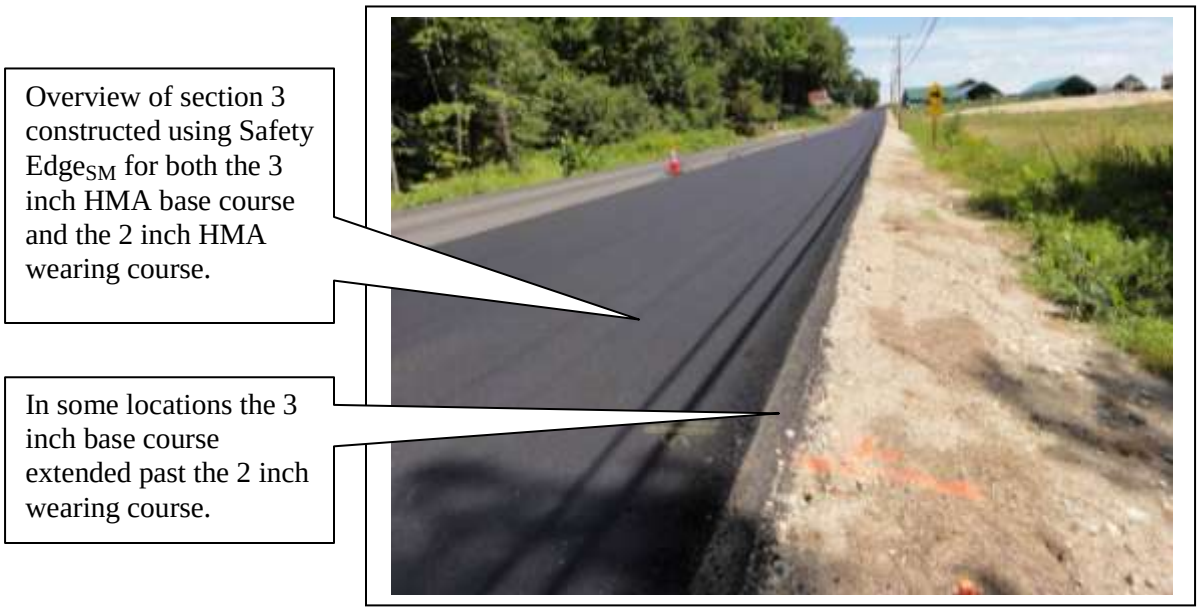
Figure 6. General overview showing the wearing course with Safety Edge$_{SM}$. Image taken facing the northbound direction around station 406+15, the end of section 3 (image shows the end of the section and the pavement north of the section).

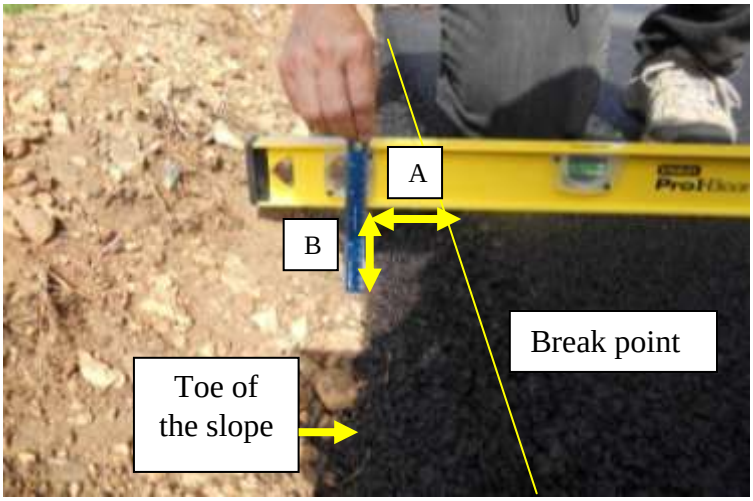
Figure 7. Measurement of Safety Edge$_{SM}$ Angle.

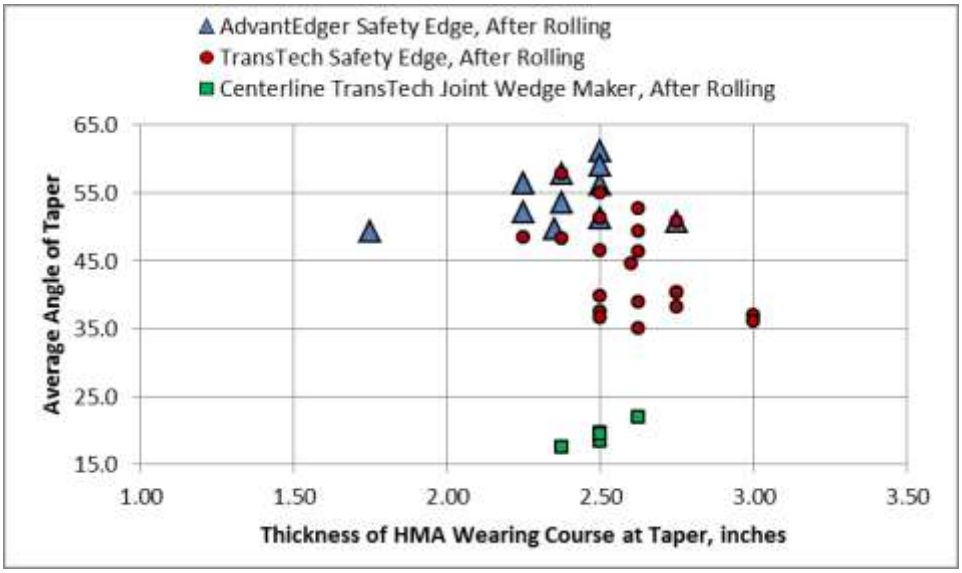
Figure 8. Comparison of the Safety Edge$_{SM}$ slope and thickness of the HMA adjacent to edge of HMA wearing course.

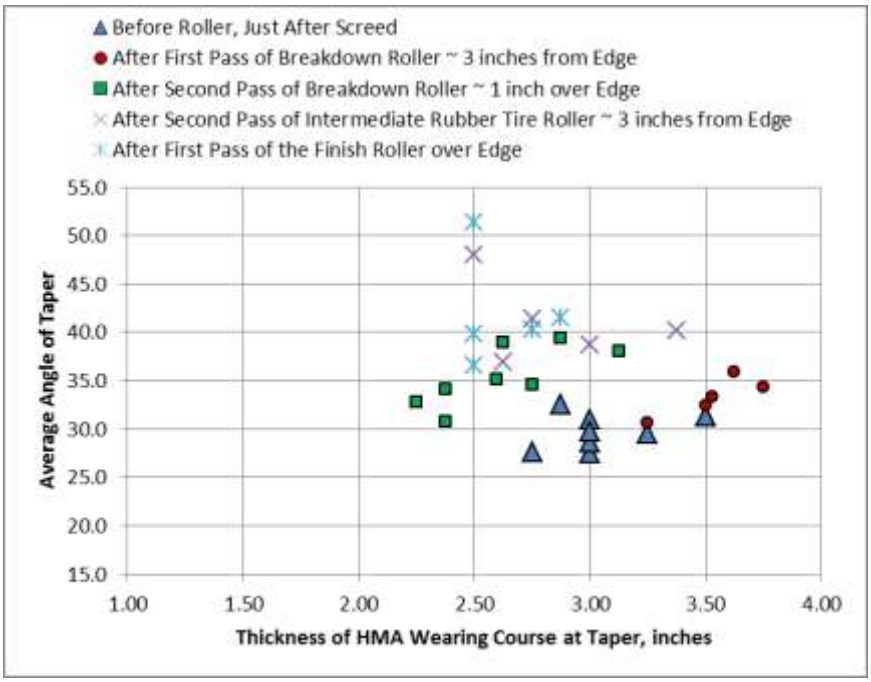
Immediately behind the screed, and prior to the rolling of the HMA mat, the average slope was 30°. After the first pass of the breakdown roller, the average slope increased to 33°. There was a corresponding increase in average thickness (by about 0.5 inches) at the edge since the first pass of the breakdown roller was approximately 3 inches from the edge, resulting in some HMA wearing course material being shoved up near the edges. Following the second pass of the breakdown roller the average slope increased to 35°. The HMA thickness near the Safety Edge$_{SM}$ was now reduced to an average value of 2.6 inches (from 3.5 inches) due to the fact that the second pass of the breakdown roller was 1 to 2 inches over the edge.

After two passes of the intermediate rubber tire roller (which did not go over the edge in either of the two passes but was approximately 3 inches from the edge), the average slope of the Safety Edge$_{SM}$ increase to 41°. There was a slight increase in thickness of the HMA mat near the Safety Edge$_{SM}$ from 2.6 inches to 2.9 inches. Following the first pass of the finish roller (over the edge) the HMA mat thickness was reduced to an average value of 2.6 inches. The average slope of the Safety Edge$_{SM}$ was 42°.

Figure 9. Effect of rolling on the angle of taper and the thickness of HMA wearing course at the taper.

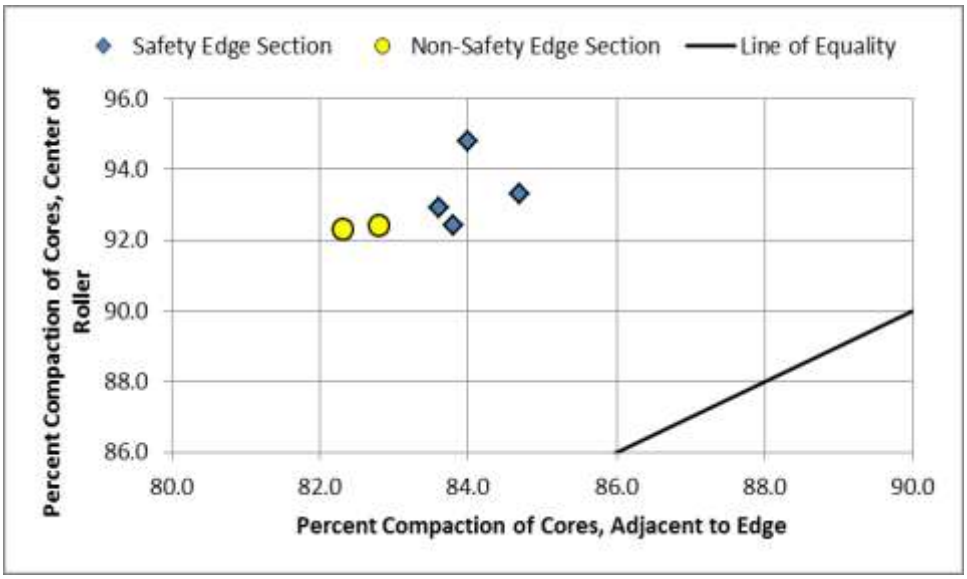
Table A-2 in Appendix A includes a summary of these test results and bulk specific gravities (saturated surface dry) converted to percent compactions. Figure 10 compares the core percent compactions taken along the edge and near the center of the steel drum roller for the Safety Edge$_{SM}$ and non-Safety Edge$_{SM}$ sections. As expected the compactions (and densities) near the center of roller are significantly higher than along the edge of the mat (unconfined edge). More importantly, the core percent compactions (and densities) taken along the pavement's edge are consistently higher for the Safety Edge$_{SM}$ section than for the non-Safety Edge$_{SM}$. These results suggest that the Safety Edge$_{SM}$ is providing better confinement for rolling an unconfined edge of the mat.

Figure 10. Comparison of core percent compactions (densities) adjacent to the edge of pavement and the near center of the roller.

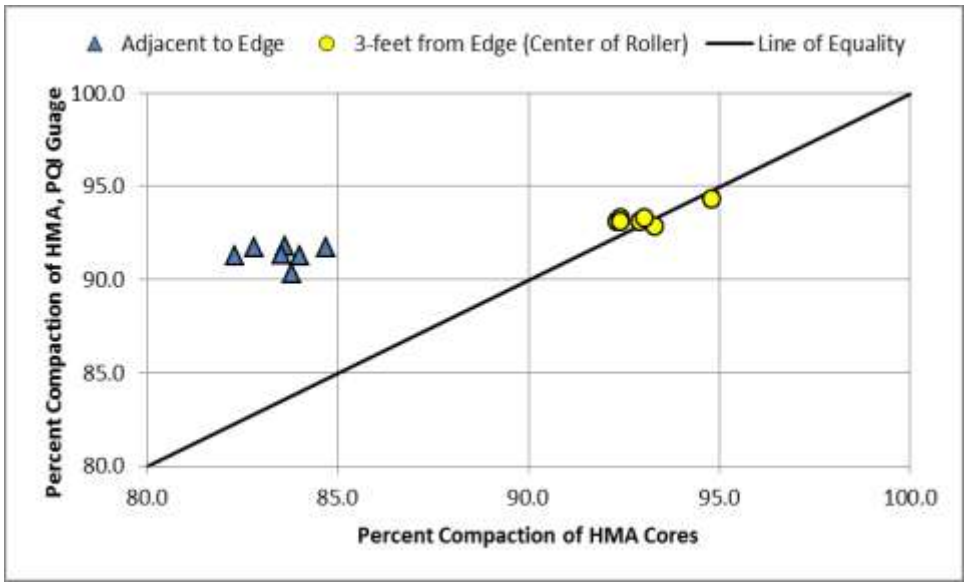
PQI readings were taken at the locations of each core. Figure 11 shows a comparison of the PQI percent compaction measurements and percent compactions measured on the cores. As shown, there is close correspondence between the PQI and core percent compactions for locations away from the Safety Edge$_{SM}$. However, for locations close to the Safety Edge$_{SM}$, the lab percent compactions (and densities) were substantially lower than that measured using the PQI. This could be due to the fact that the PQI was calibrated for the higher mat densities and not for the lower densities at the edges. Adjustment factors were determined for the PQI percent compaction readings taken at the Safety Edge$_{SM}$ and near the center of the steel drum roller being used to compact the HMA mat. The adjustment factors are included in

Figure 11. Comparison of the PQI percent compaction readings and percent compactions measured on cores recovered from the HMA wearing course.

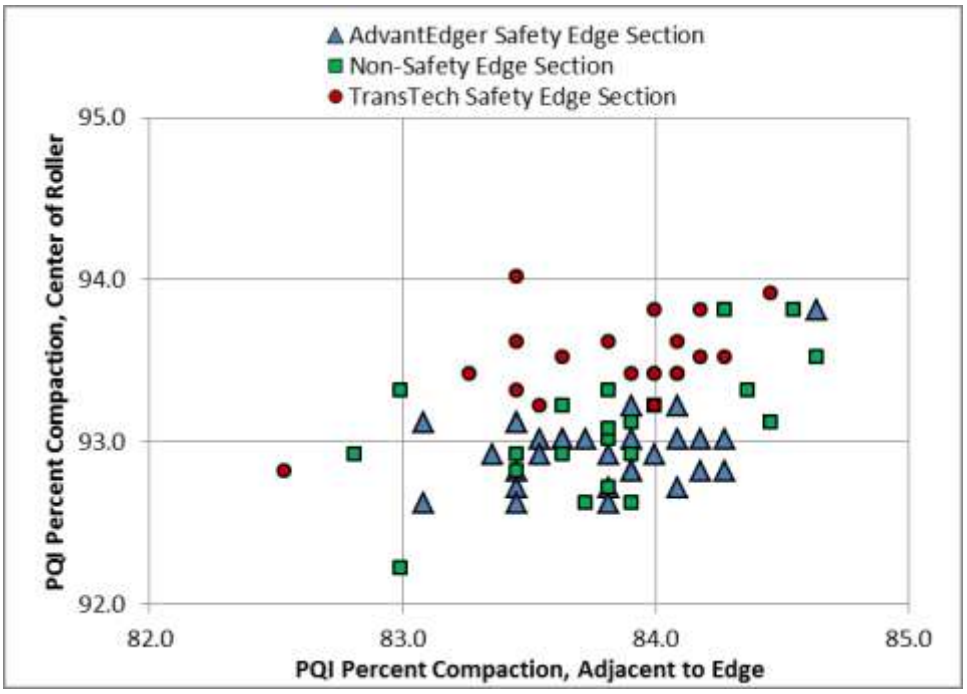
Figure 12 shows a comparison of the adjusted PQI gauge readings taken adjacent to the Safety Edge$_{SM}$ and in the center of the vibratory steel wheel roller. As shown in the figure, the percent compaction near the edge (unconfined edge) for both the Safety Edge$_{SM}$ sections and the control section is substantially lower than the percent compaction at the center of the roller (confined edge).

Figure 12. Comparison of the adjusted PQI percent compaction readings between the areas adjacent to the edge and center of the steel drum roller.

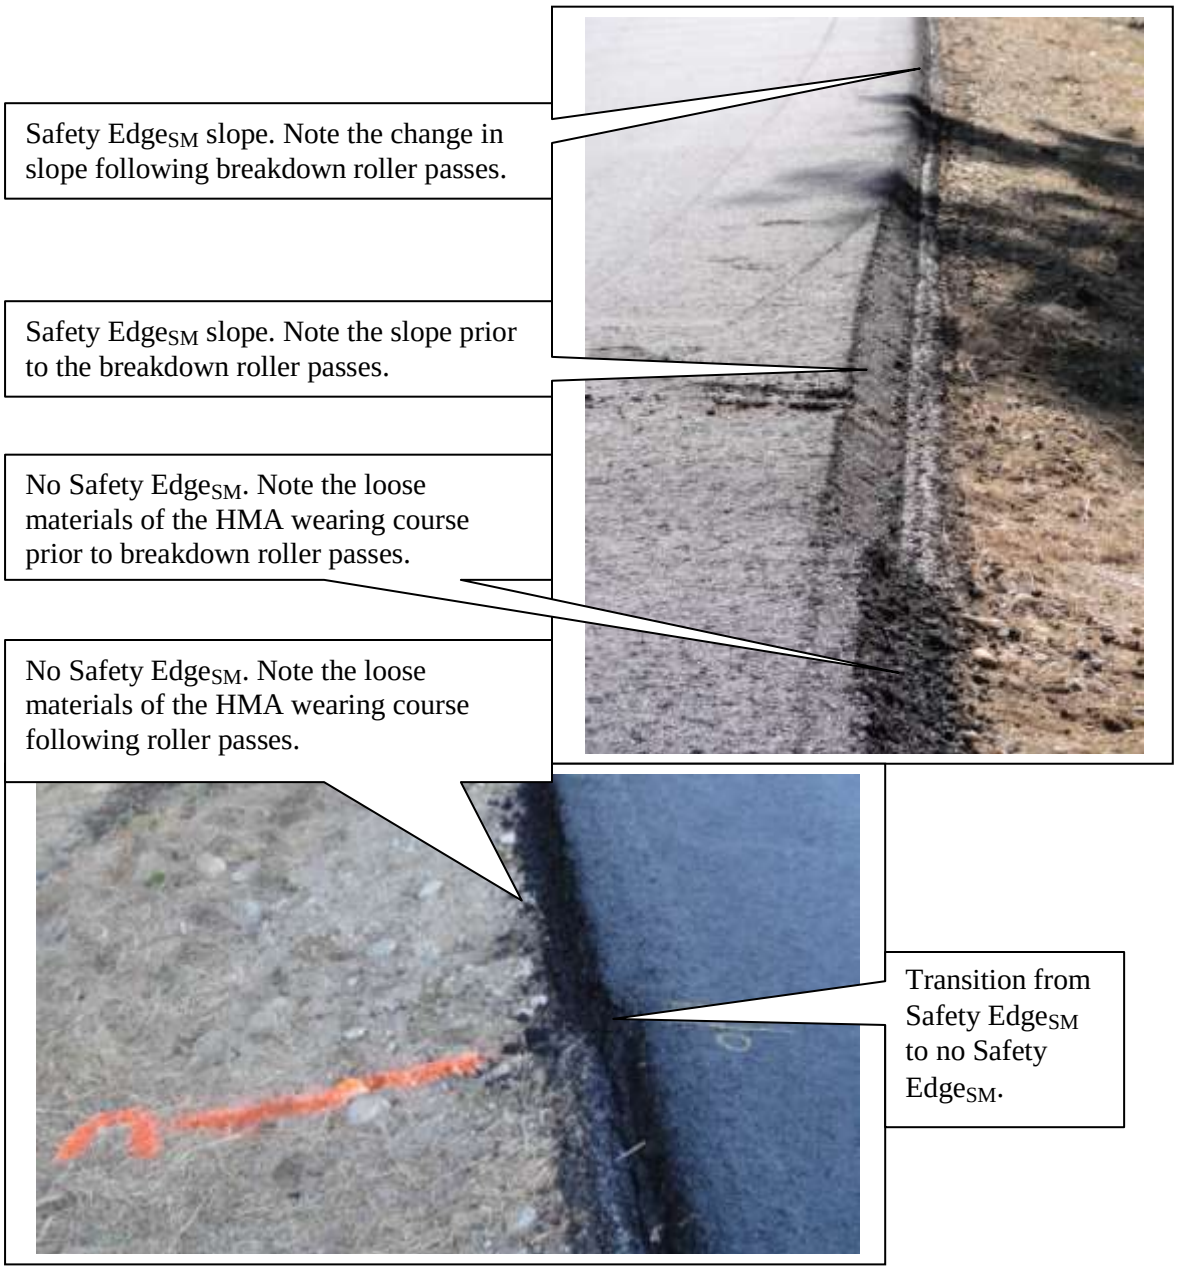
The edge of the wearing course placed without a Safety Edge$_{SM}$ had loose HMA material whereas the shape of the Safety Edge$_{SM}$ was smoother and uniform prior to rolling. After rolling the non-Safety Edge$_{SM}$ still had loose HMA material and the shape Safety Edge$_{SM}$ was still uniform but increased in slope. Figure 15 shows the appearance of the Safety Edge$_{SM}$ and non-Safety Edge$_{SM}$ sections. A close view of the loose-uncompacted HMA at the edge of the non-Safety Edge$_{SM}$ section is shown in Figure 16. One of the benefits of the Safety Edge$_{SM}$ is a relatively smooth edge of pavement.

Figure 15. Appearance of the wearing course of the Safety Edge$_{SM}$ and non-Safety Edge$_{SM}$ sections.

Figure 16. Non-Safety Edge$_{SM}$ control section showing the lack of density at edges even after roller passes.

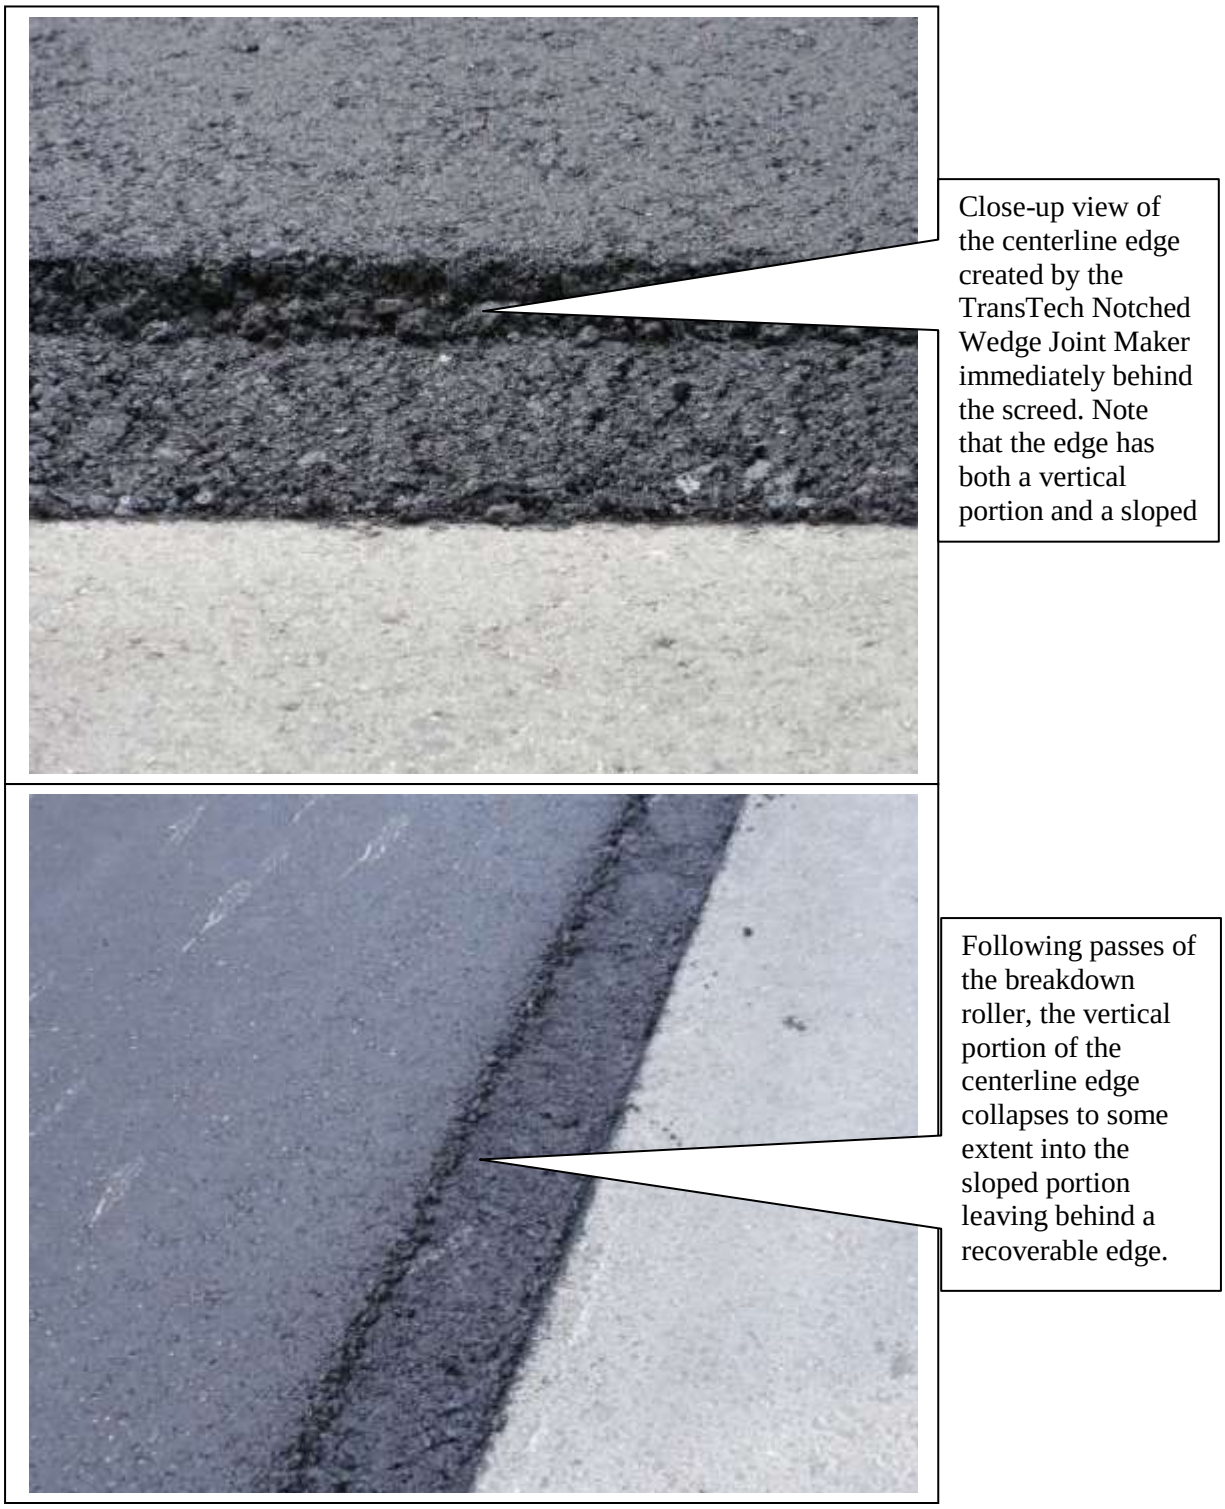
This project also included use of the TransTech Notched Wedge Joint Maker for the centerline joint (which is expected could be adapted to form a Safety Edge$_{SM}$). Figure 17 shows the vertical edge of the centerline joint is slightly reduced after rolling leaving behind an easily mountable edge for vehicles.

Figure 17. Centerline joint paved using the TransTech Notched Wedge Joint Maker before and after breakdown roller passes.

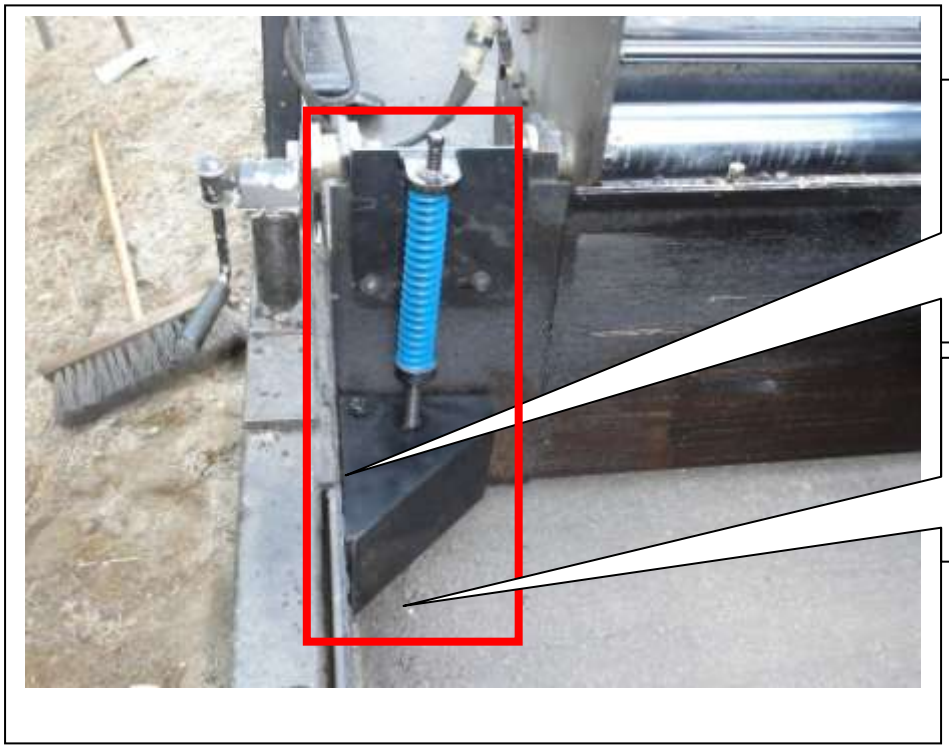
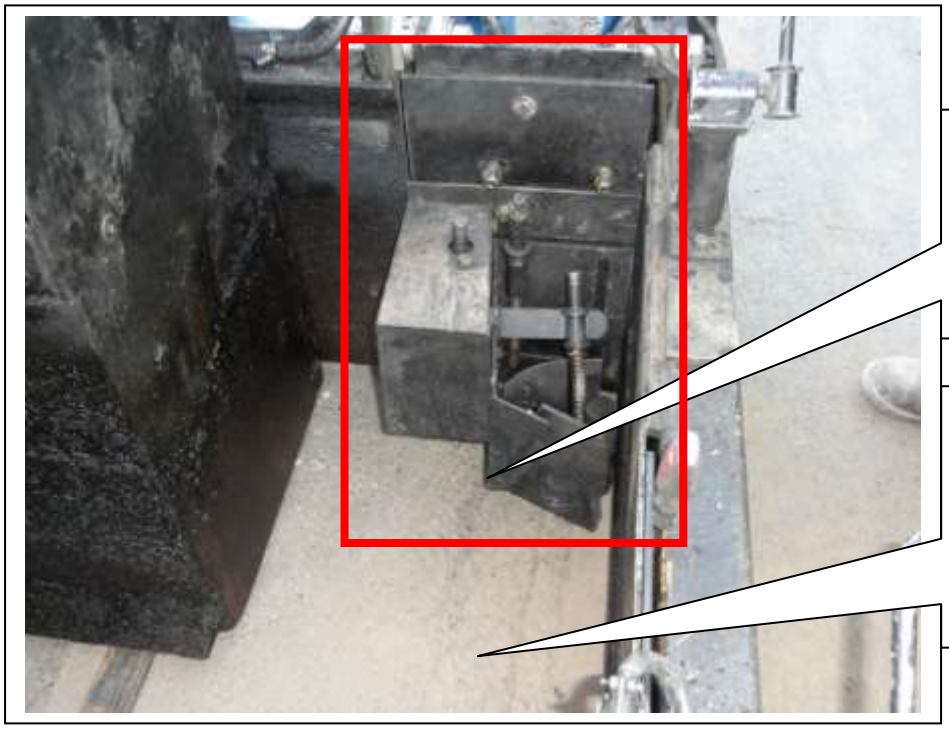
End of paver material feed auger was about 2.5 feet from end gate on the Safety Edge$_{SM}$ side. Paver equipment manufacturers recommend that the auger be no more than 18 inches from end gate.

Figure 19. TransTech Shoulder Wedge Maker and TransTech Notched Wedge Joint Maker attached to the screed.
