Federal Highway Administration
Every Day Counts
Innovation Initiative

Safety Edge$_{SM}$ Demonstration Project Brogden Road in Johnston County, North Carolina

Field Report
June 1, 2011

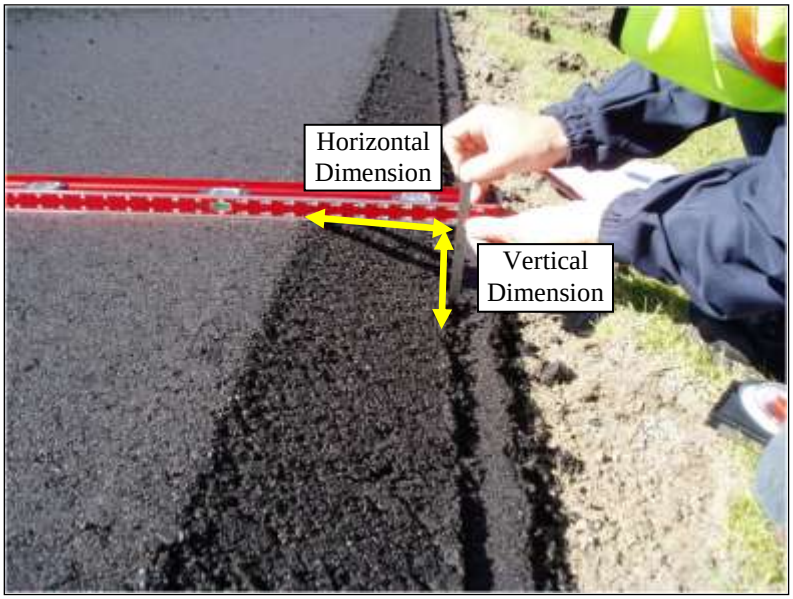
Figure 2. Slope measurement technique.

Slope measurements were recorded on test sections #1 and #2 at 25-foot intervals using a straight-edge and ruler to measure the horizontal and vertical dimensions of the edge (see Figure 2). The following summarizes the average slope measurements:

Pavement Section	Slope
Test Section #1, Troxler Device	28°
Test Section #2, NCDOT Device	26°
Section #3, Control	NA

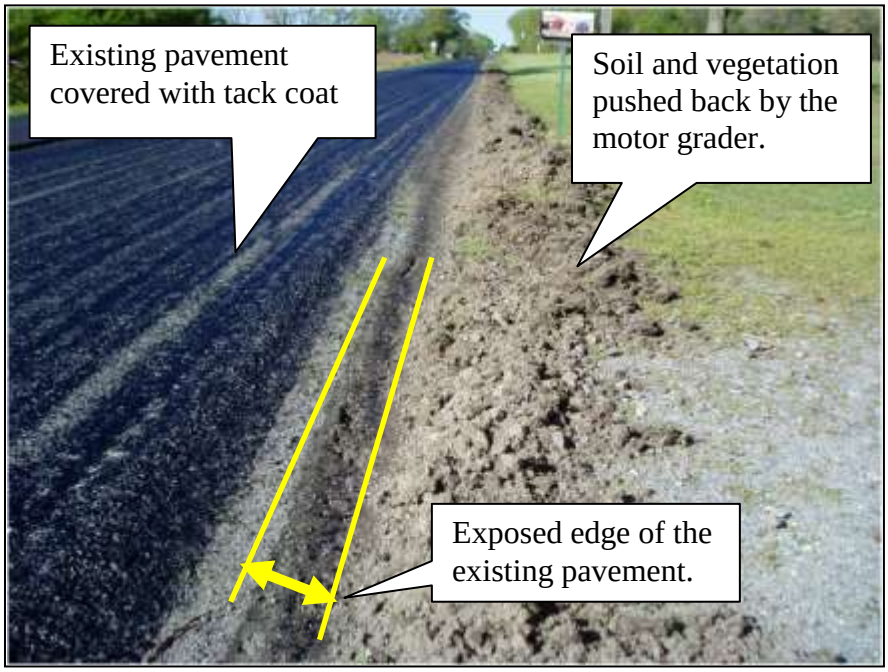
Figure 7. Exposed pavement after edge preparation.

For this project it is key that the contractor's standard operating practice includes preparing the edge of the existing pavement. If soil/vegetation adjacent to the pavement is encroaching onto the pavement and/or is higher than the pavement, it is necessary to remove this material to expose the existing pavement edge. This condition often results in poor drainage of the existing surface. Figure 7 shows the exposed pavement after clipping the edge buildup.

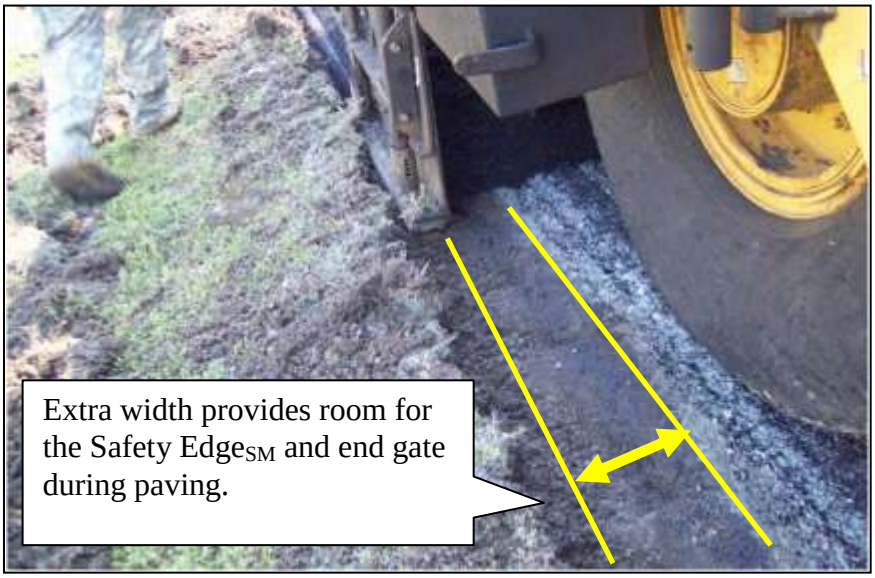
Figure 8. Extra width created by preparing the existing pavement edge/shoulder.

Paving over vegetation results in poor consolidation, and the asphalt material is not expected to perform as well as it would when paved on the existing pavement and soil/aggregate shoulder material. Essentially, the result will be as if no Safety Edge$_{SM}$ were placed. The Safety Edge$_{SM}$ requires a few more inches of clipping width compared to traditional paving without a Safety Edge$_{SM}$. The extra width shown in Figure 8 accommodates not only the Safety Edge$_{SM}$ but the end gate of the paver as well.

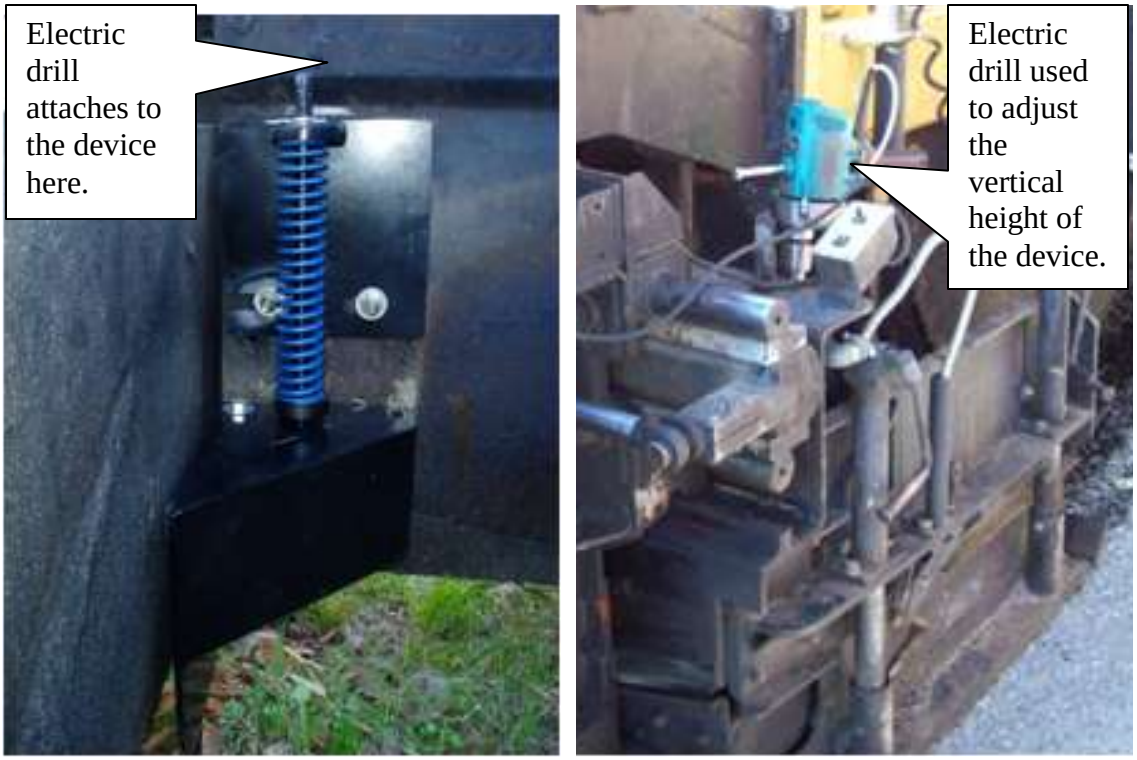
Figure 11. Troxler SafeT*Slop*e Edge Smoother.

The contractor had no problems operating the Troxler device. The device was raised and lowered quickly with an electric drill attached to the top of the vertical screw shown in Figure 12. Two bolts welded to the face of the screed box held the device in place. As shown in Figure 12, the shoe was free to swing horizontally. Under normal operation the lateral pressure of the asphalt mix holds the shoe against the end gate; however, asphalt can build up between the two surfaces, pushing the shoe to the inside and causing problems, such as increased edge slope angle.

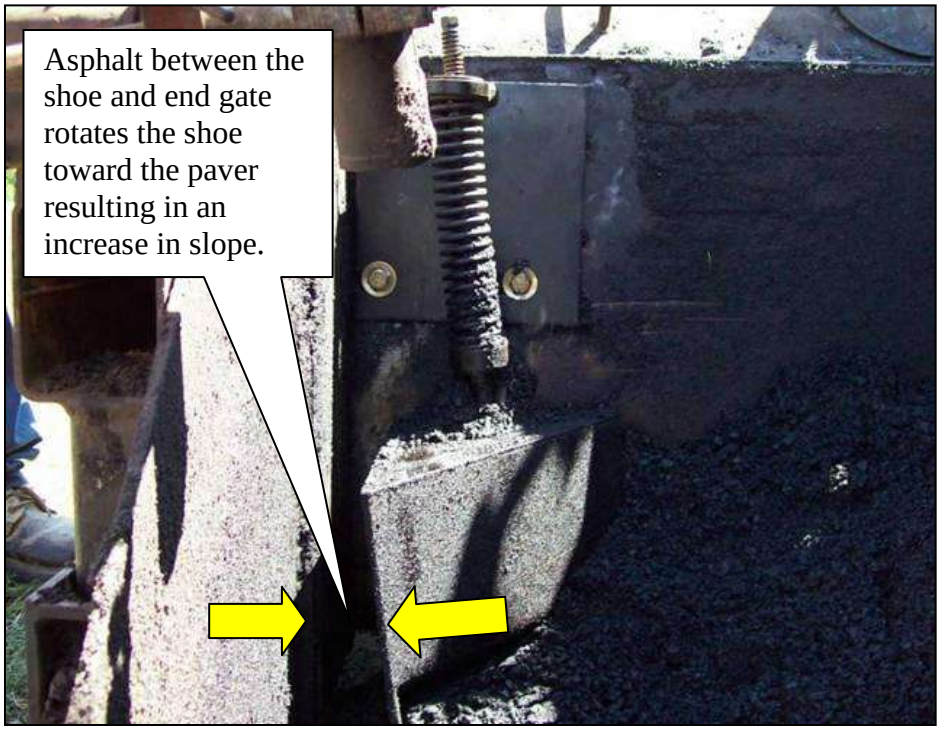
Figure 15. Shoe rotation.

NCDOT purchased two TransTech Shoulder Wedge Makers in 2006. During the first two installations (about 2008 to 2009), NCDOT noticed the final angles approached 45°. Upon investigation of site implementation photos, NCDOT noticed that the shoe was rotating (moving horizontally) from asphalt getting between the end gate and the shoe. Figure 15 shows the shoe rotated toward the paver.

NCDOT decided to make a back plate similar to the Advant-Edger back plate. For the current routes that would receive the Safety Edge$_{SM}$ (first route paved on March 18, 2011), the first change made to the TransTech device was to make a different back plate. NCDOT's first prototype combined the TransTech device with a custom backplate 16 inches long with 2-inch sides for the guide plates on the side with one set of placement slots to attach to the paver. Instead of drilling holes and bolting the device to the screed box, the contractor tack welded two bolt ends to the screed box to attach the device. Figure 16 shows NCDOT's first prototype. Within the first 0.75 mile of use, the contractor snagged a driveway with the device, tore the back plate edge guides, and severely bent the screw.

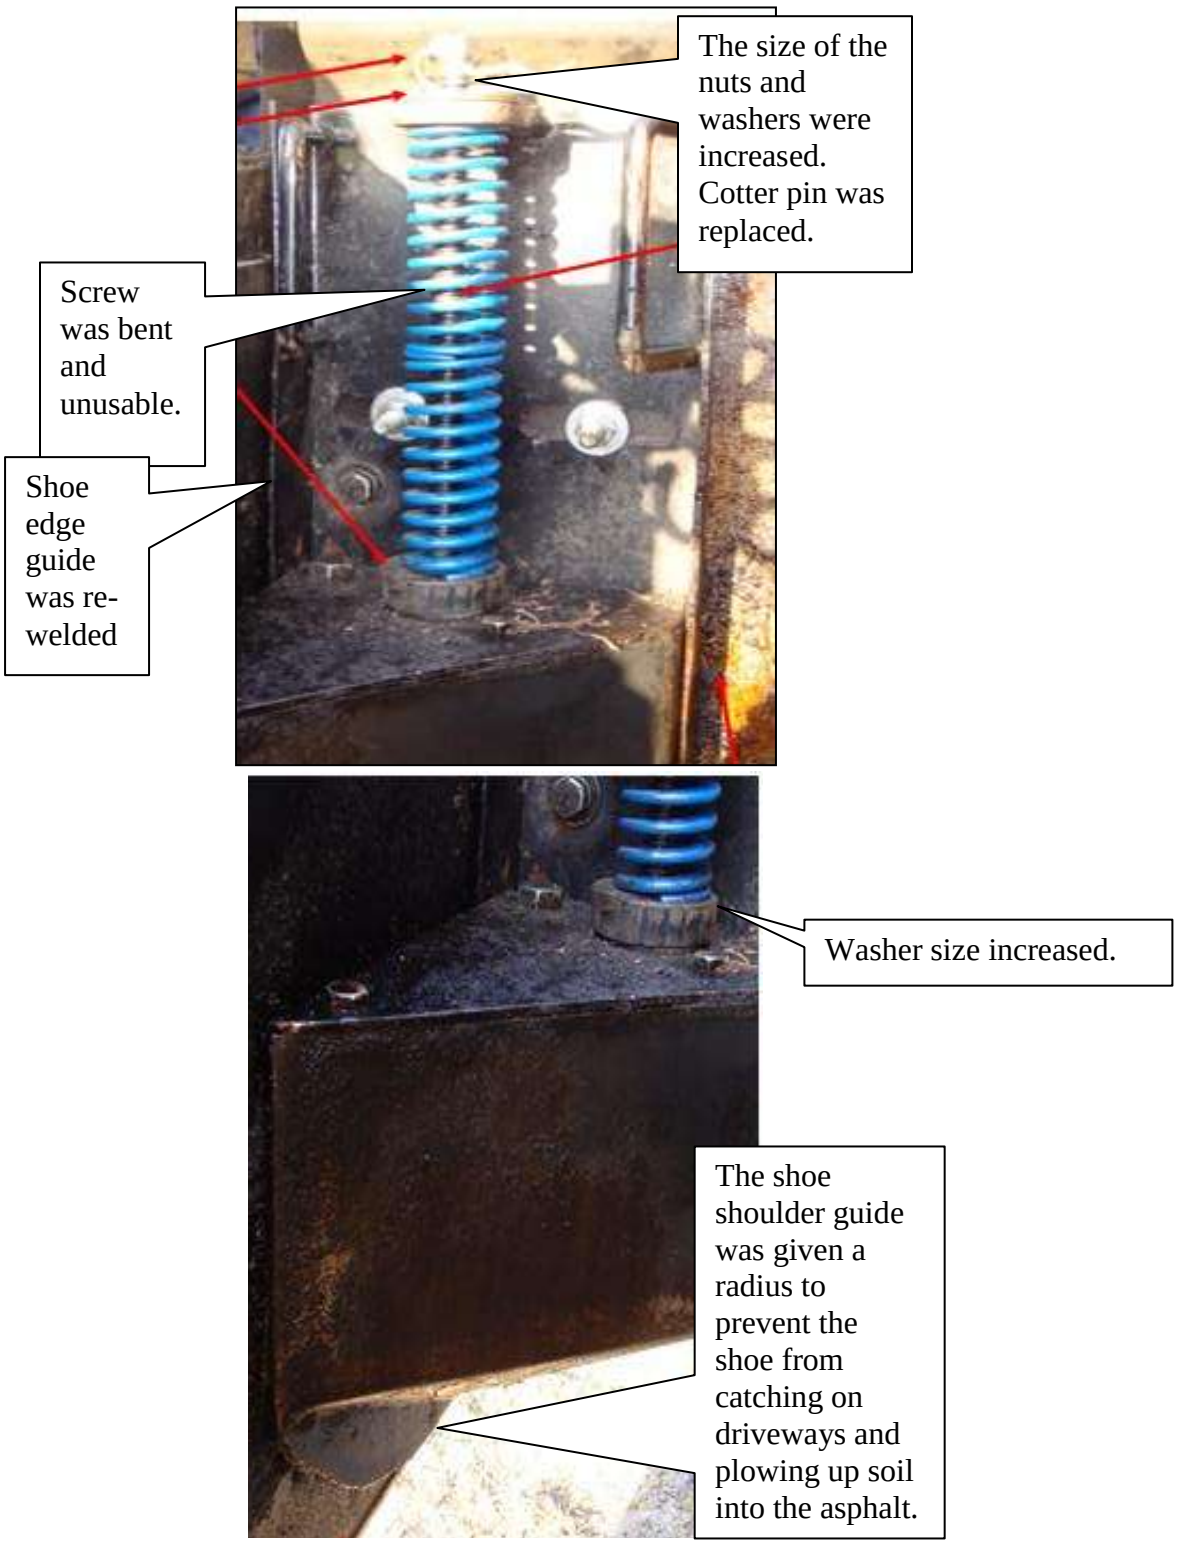
Figure 17. Images of the NCDOT's first prototype after modification.

The next modification was to cut a radius into the leading edge of the shoe guide so it would no longer snag on driveways (this also reduced/eliminated the plowing of soil into the asphalt Safety Edge$_{SM}$). The screw and back plate edge guides were repaired, the cotter pin was replaced, and a new screw nut was welded into place. Figure 17 shows the modifications made to NCDOT's first prototype. The contractor finished the first four routes with the modified prototype.

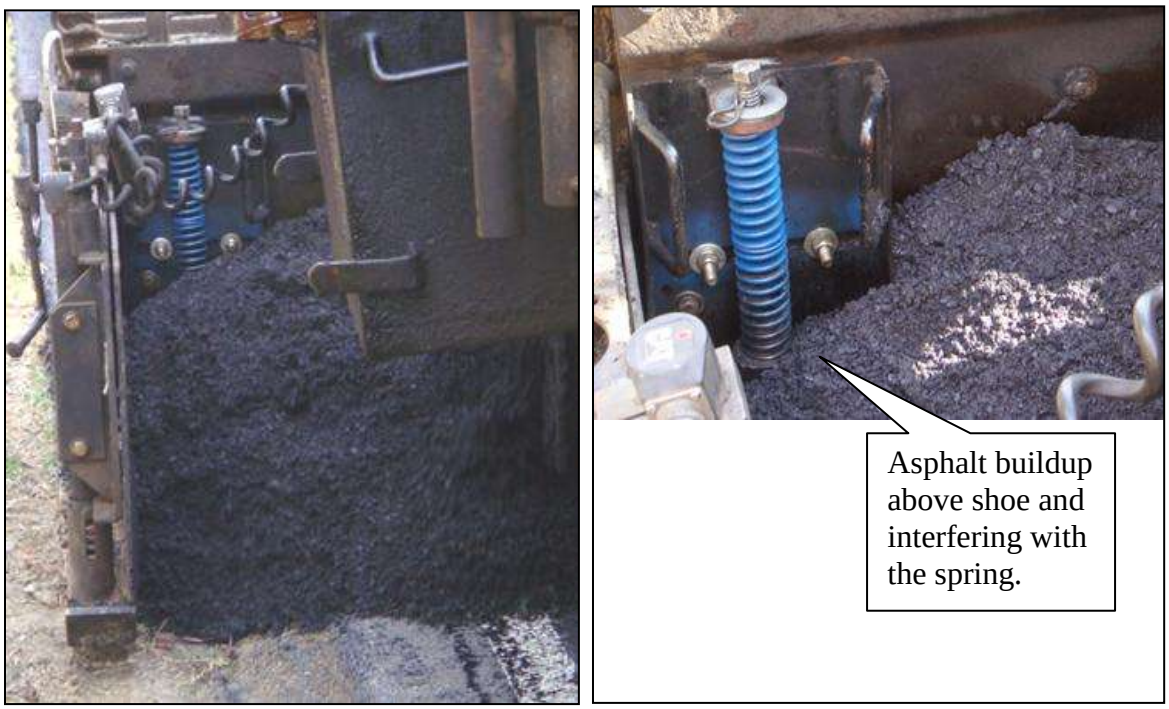
Figure 18. Asphalt buildup above the shoe.

During the paving of the second, third, and fourth routes, the contractor had problems raising the device at driveways due to asphalt collecting above the shoe and interfering with the screw/spring. In fact, on the fourth route, the contractor had to remove the device seven times due to the multiple driveways and being unable to raise the device (on a 0.64-mile section of road). This process included stopping the paver, digging out the device, removing the device, paving across the driveway, stopping the paver, digging out the asphalt for the device to be placed back against the screed box and end gate, and finally reattaching the device. This process took 5 to 10 minutes each time (which the contractor estimated as equivalent to not placing one truckload of asphalt).

NCDOT developed a second prototype based on the experience gained with the first prototype. The second prototype back plate was built with 18-inch-long sides; the side closest to the end gate was built with 2-inch-deep guide plates, and the side closest to the material feed auger was built with 3-inch-deep guide plates. An 8-inch protection plate was bolted to the top of the shoe to prevent asphalt from reaching the screw and spring. Multiple mounting slots were cut into the back plate to accommodate different types of pavers. Figures 19, 20, and 21 show the details of the second prototype.

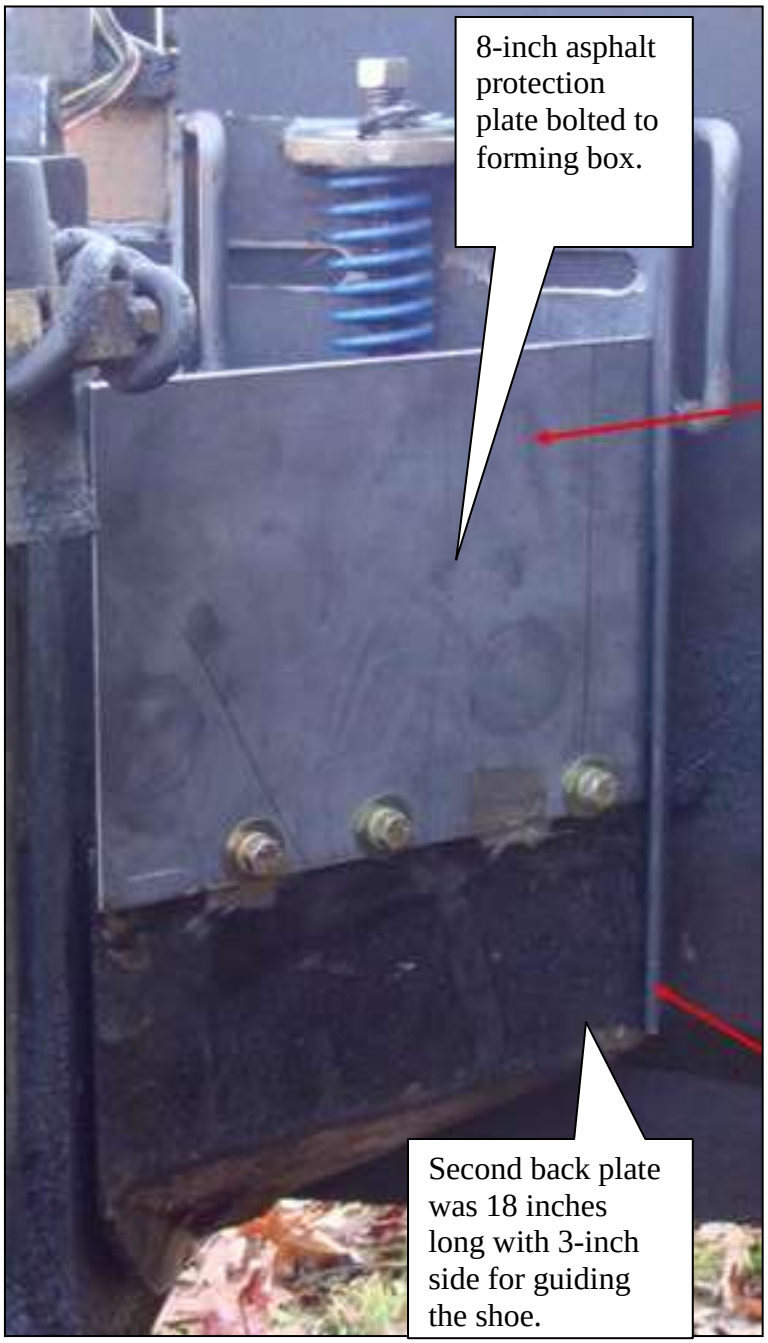
Figure 19. NCDOT's second prototype showing the protection plate and revised back plate and shoe guide.

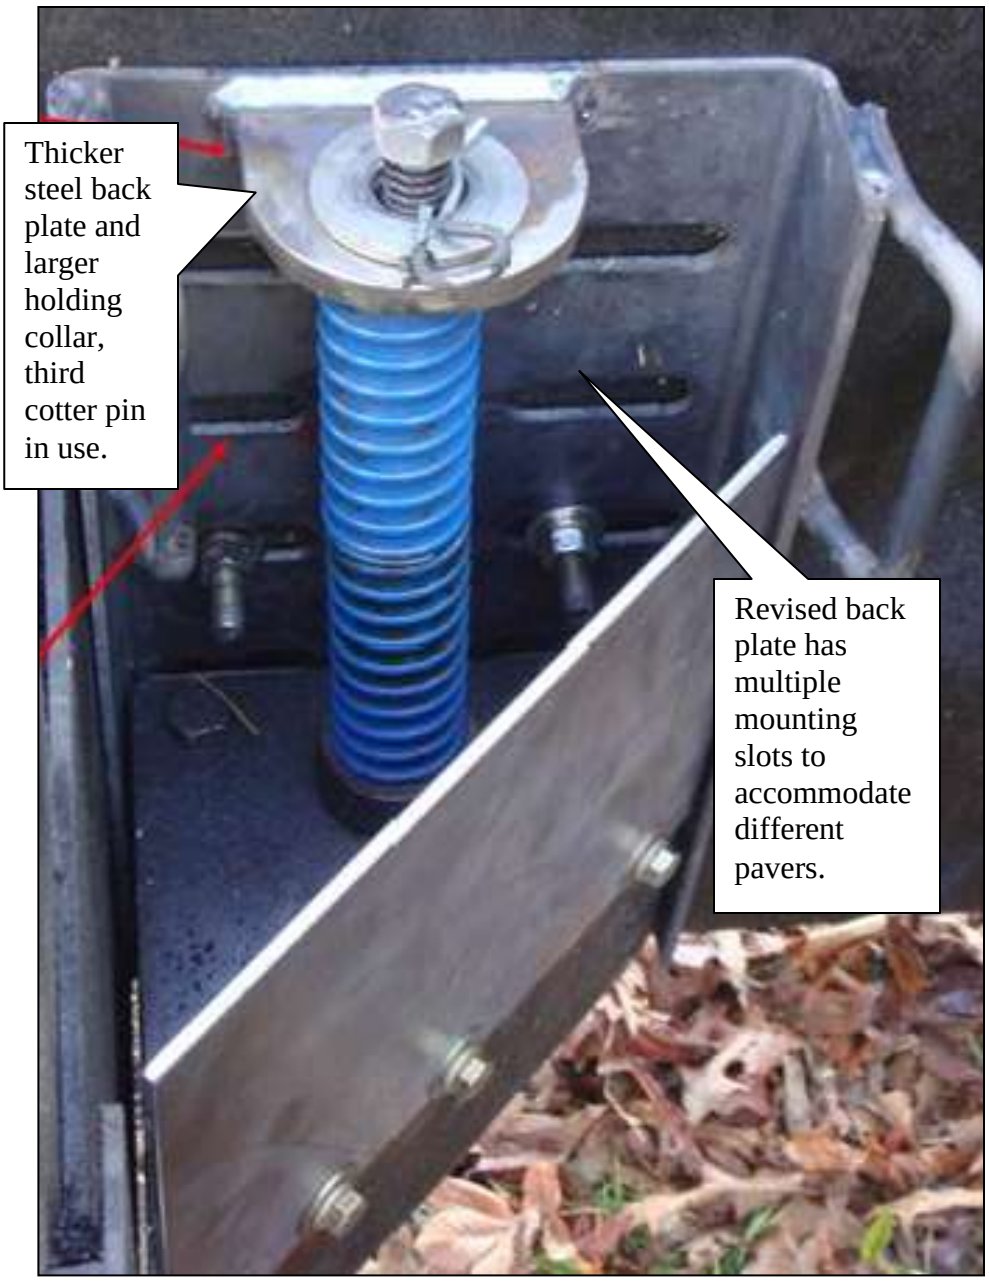
Figure 20. NCDOT's second prototype showing a thicker back plate, larger holding collar and multiple mounting slots.

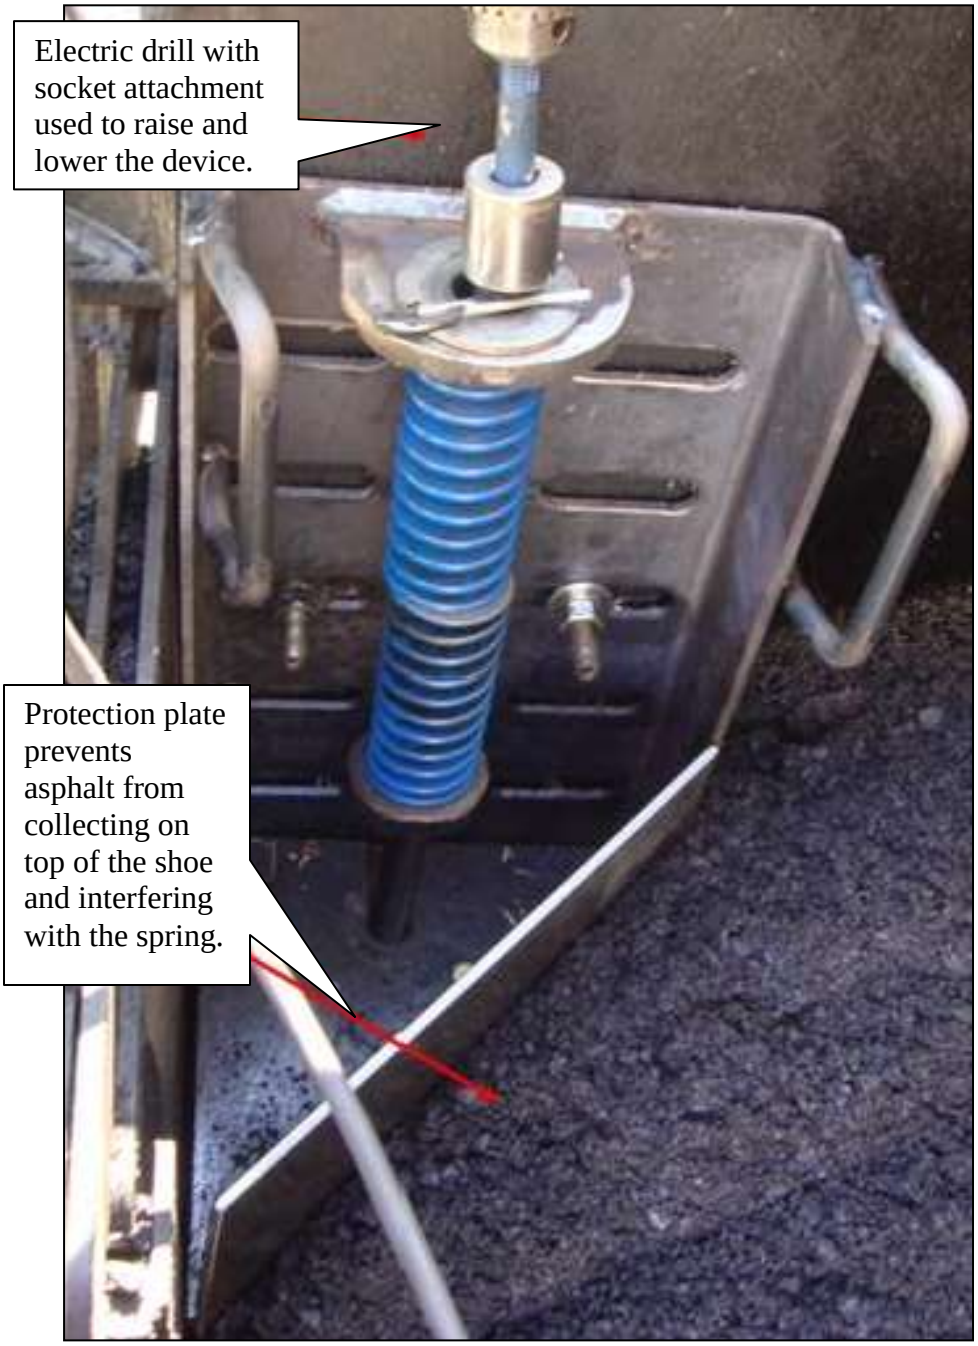
Figure 21. NCDOT second prototype in service showing the protection plate keeping asphalt from collecting on top of the shoe.
