Federal Highway Administration
Every Day Counts
Innovation Initiative

Safety Edge$_{SM}$ Demonstration Project Elizabethtown, Pennsylvania

Field Report
May 24, 2011

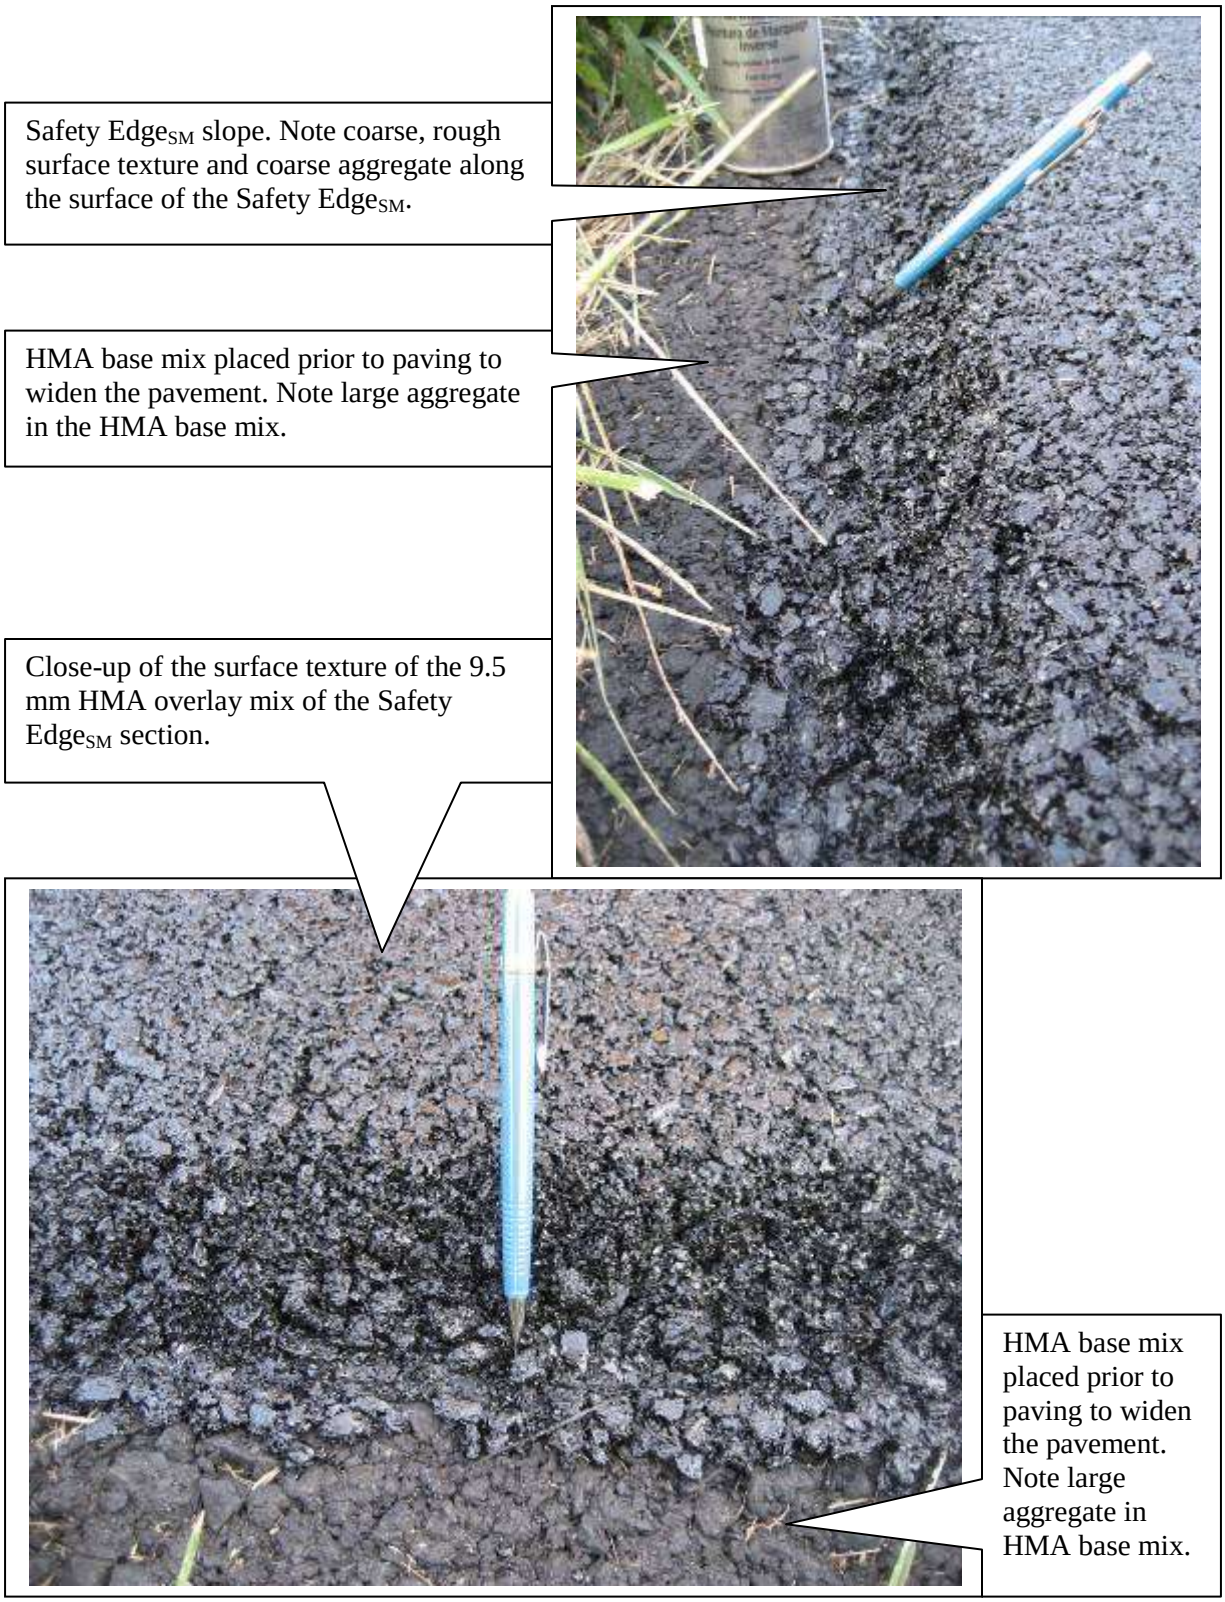
As noted above, the existing pavement was widened on both sides by about 1 foot, by placing an HMA base mix (refer to Figure 4). The HMA base mix had already been placed along the pavement's edge. The surface of this material was rough, as shown in Figures 4 and 5. The width of the pavement varied significantly along the project because of site features and driveways that exist along the project (refer to Figures 3 and 6).

Figure 4. Additional HMA base material placed along each edge of the roadway.

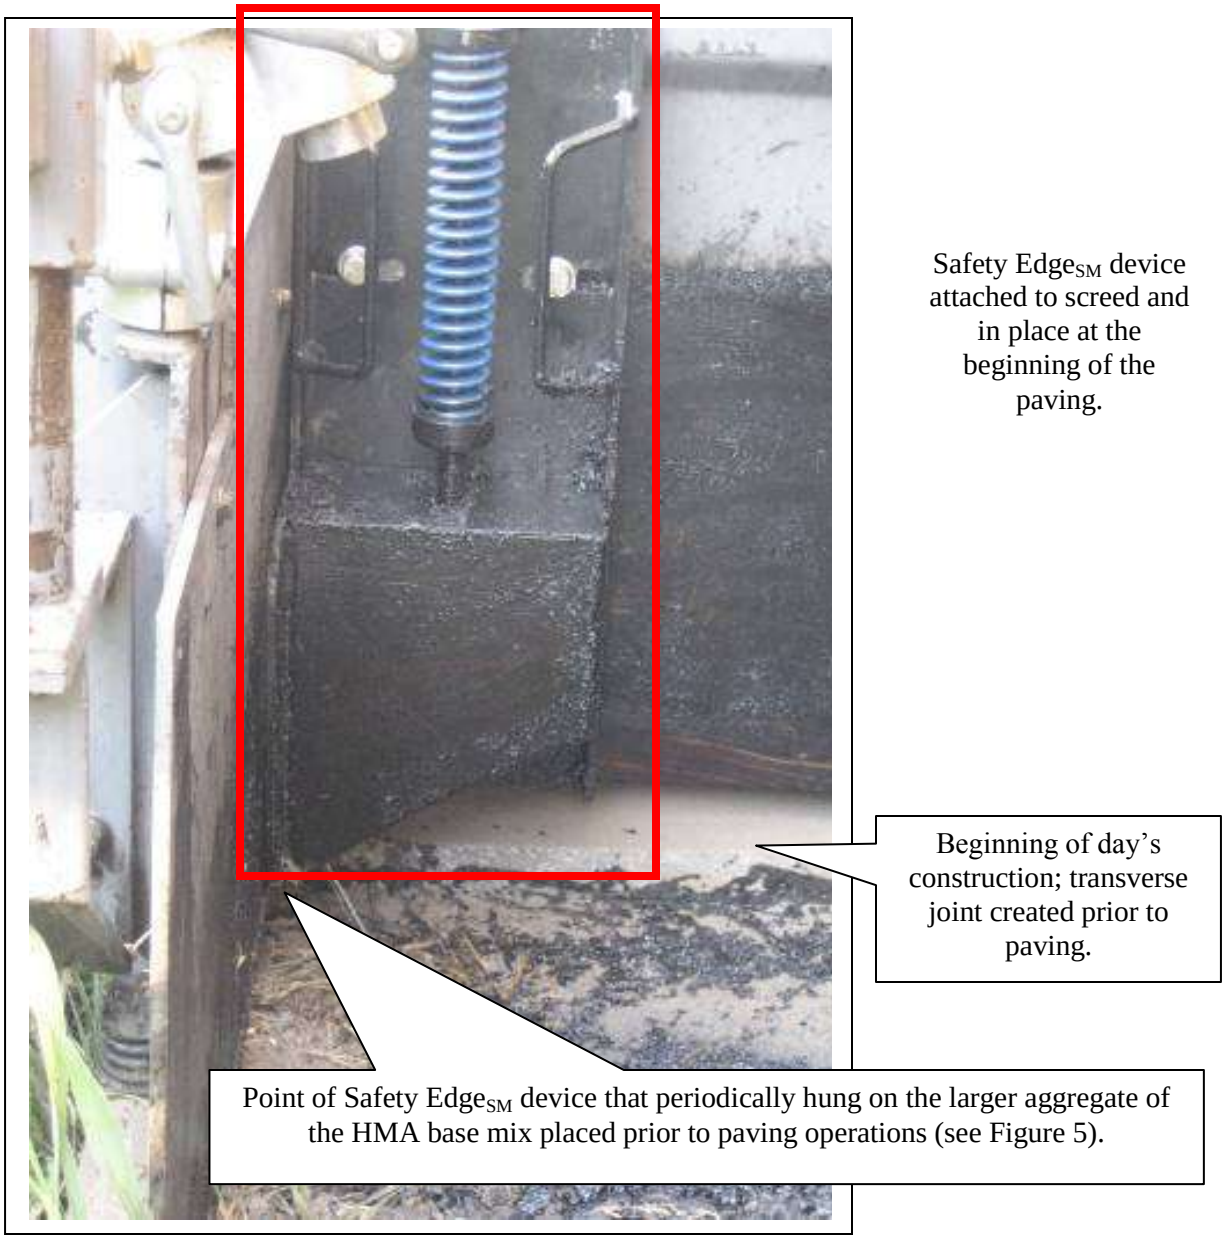
Figure 17. Safety Edge$_{SM}$ device attached to the screed.

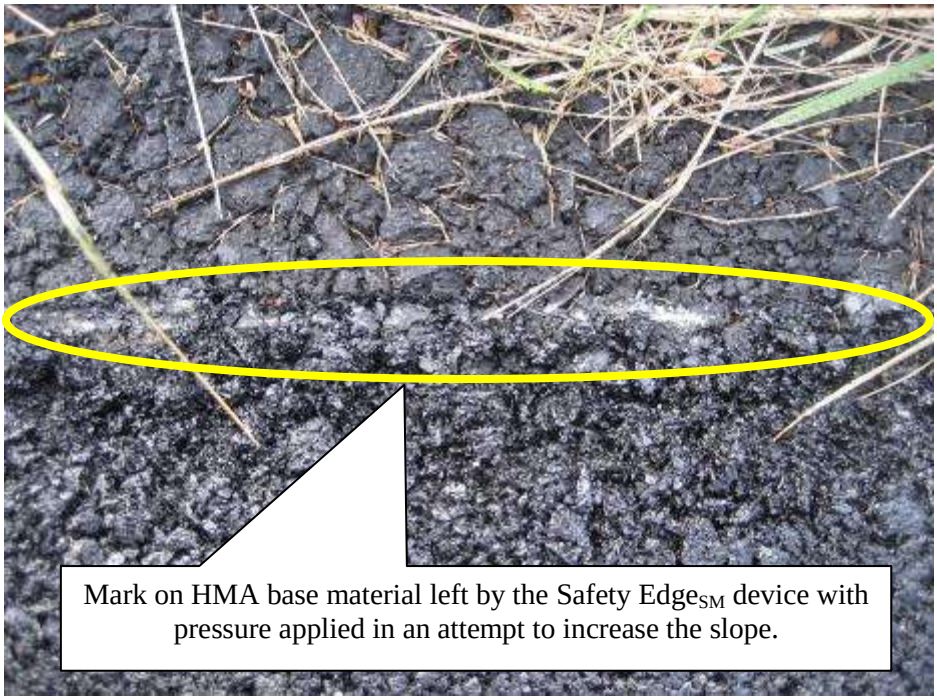
Edge$_{SM}$ device down onto the HMA base in accordance with the manufacturer recommendations, which was evident by scratch marks on the surface of the HMA base (refer to Figure 18 that shows this condition). It is expected that excessive downward pressure exerted on the Safety Edge$_{SM}$ device could cause the screed to rise in areas where the device was in contact with the HMA base. To prevent this condition, the screed operator suggested raising the Safety Edge$_{SM}$ device to a height about 0.5 inches above the bottom of the end plate. The screed operator also suggested attaching the Safety Edge$_{SM}$ device to the screed end plate rather than to the screed. The screed end plate, however, would need to be significantly stiffened.

Figure 18. Gouges in the HMA left by the Safety Edge$_{SM}$ device riding on the surface of HMA base mix.
